Washington County Lead District – Potosi Area Site
Soil Excavation and Sampling
Access Agreement

WASHINGTON COUNTY LEAD DISTRICT - POTOSI AREA SITE
PRE-EXCAVATION HOME INSPECTION CHECKLIST

Potosi Site Site Sketch

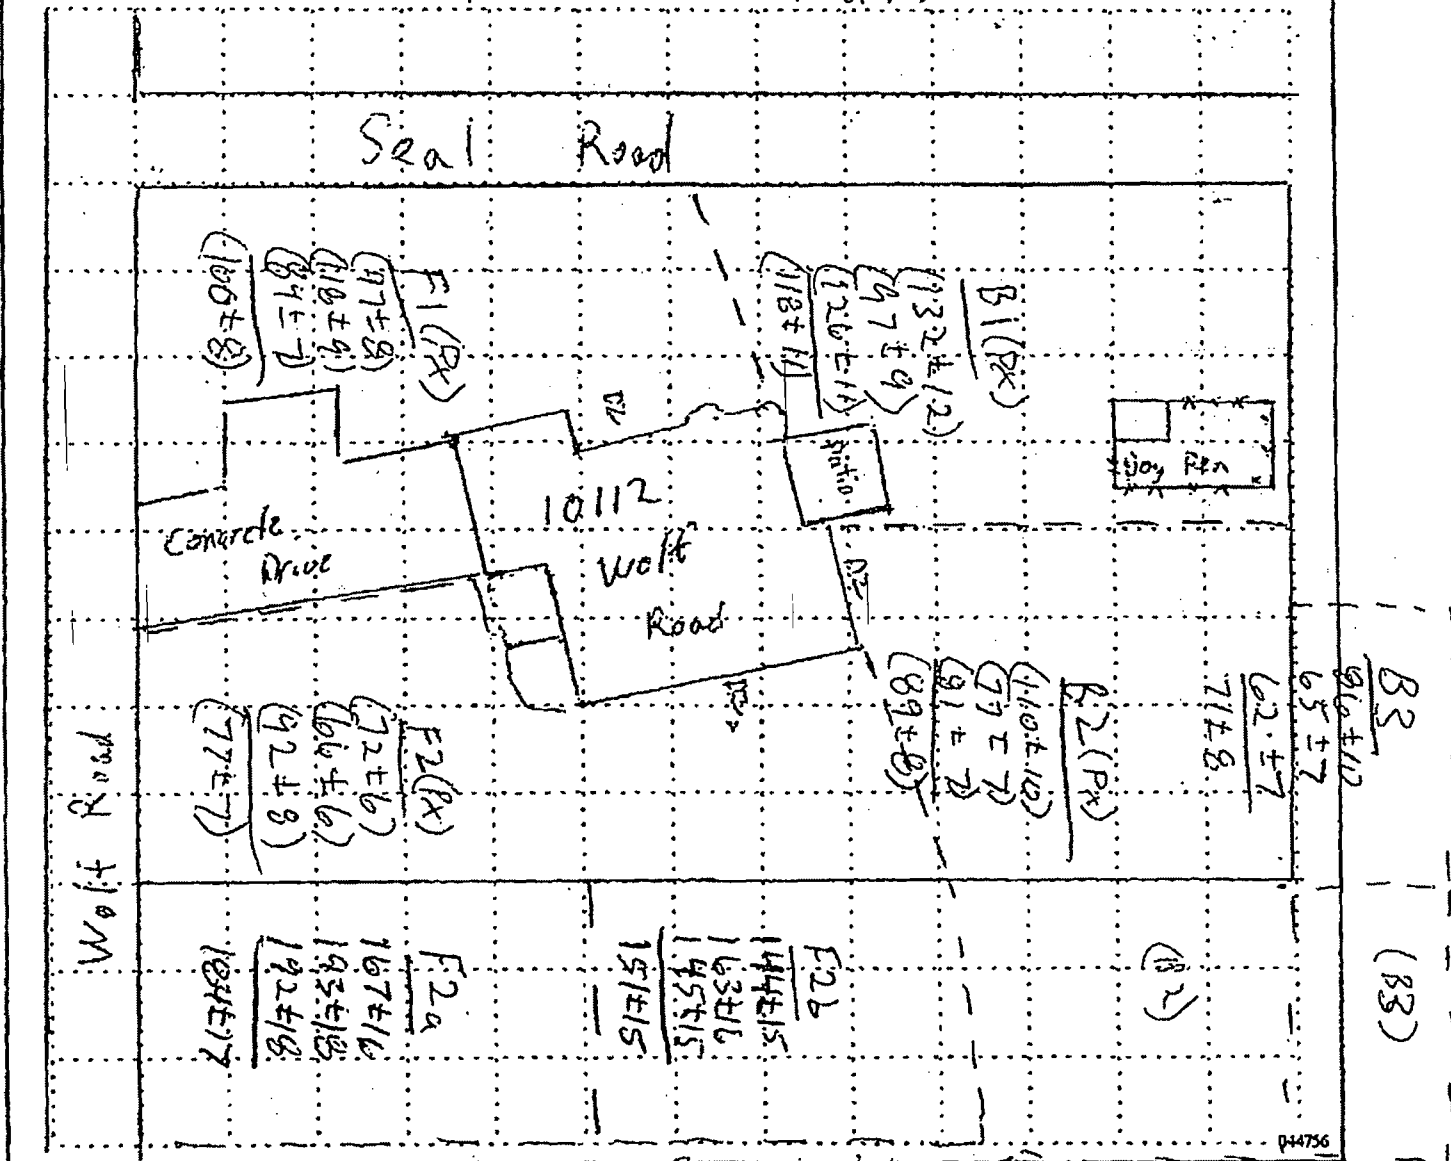
F1	<u>765</u>	ppm	<input checked="" type="checkbox"/>	<input type="checkbox"/>
F2	<u>458</u>	ppm	<input checked="" type="checkbox"/>	<input type="checkbox"/>
B1	<u>468</u>	ppm	<input checked="" type="checkbox"/>	<input type="checkbox"/>
B2	<u>893</u>	ppm	<input checked="" type="checkbox"/>	<input type="checkbox"/>
DZ	<u>770</u>	ppm	<input checked="" type="checkbox"/>	<input type="checkbox"/>
GZ		ppm	<input type="checkbox"/>	<input type="checkbox"/>
PZ		ppm	<input type="checkbox"/>	<input type="checkbox"/>

-
- New Cell (B3) sampled to determine lead levels (Pre-ex).
 - ~~- Cells F2a + F2b split from F2 and resampled to include~~
 - Cells F2a + F2b sampled (Pre-ex) to include yard area up to the property line,
 - Most of property excavated 3-6 inches bys to remove contaminated fill above 400 ppm,
